**Channel Migration Zone Delineation
Upper White River**

RM 44.5 to 51.5

Near Town of Greenwater
Pierce County, Washington

**Pierce County Planning and Public Works
Surface Water Management**

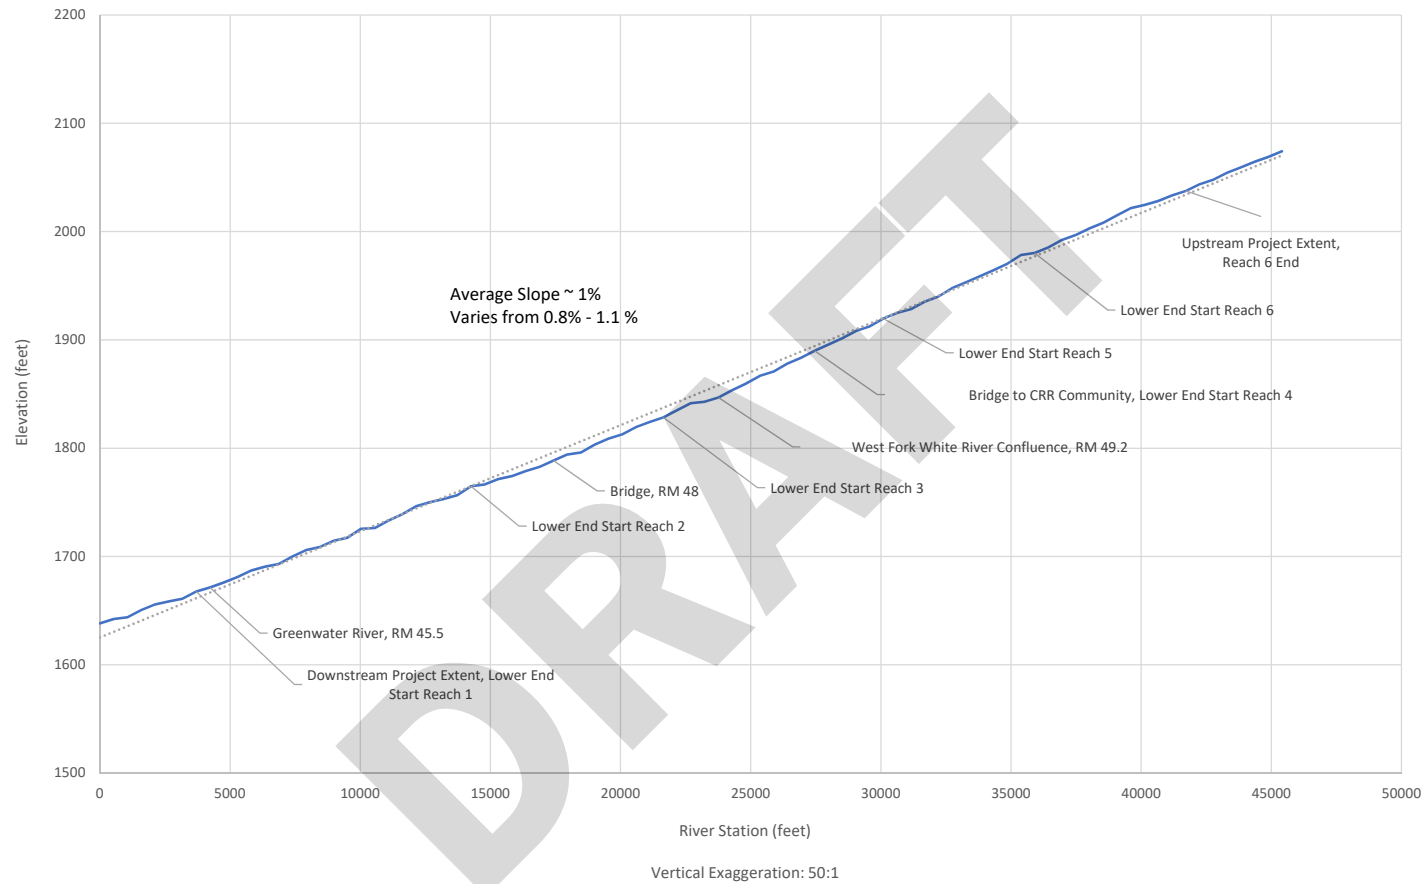
Figure 5

LiDAR 2010 Water Surface Elevation Profile

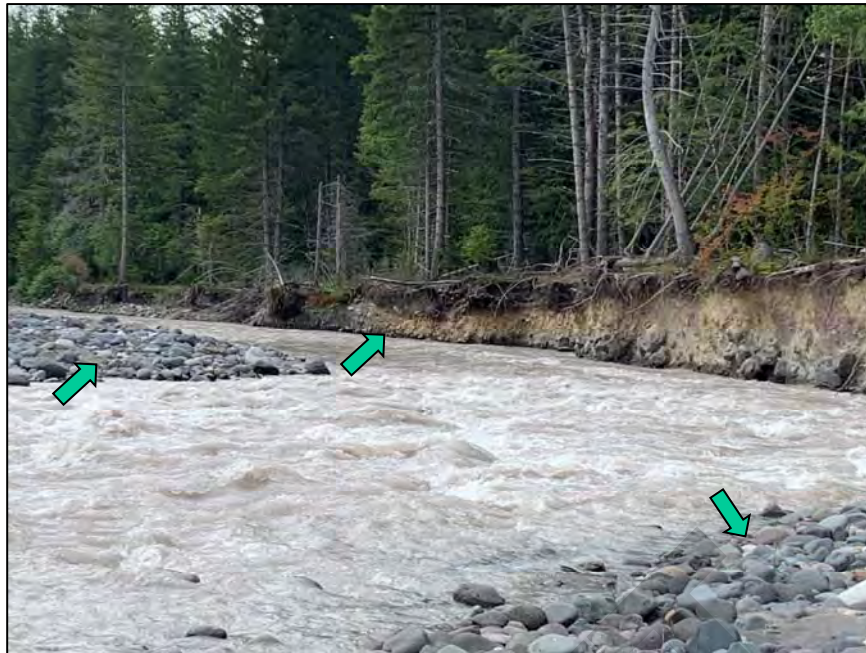
Photograph 1. Bar material and Osceola Mudflow with a dark soil layer above and interface with alluvium at center of photo. Soil layer covers both units. Near RM 47.5.

The upper White River is predominantly a riffle-glide bedform. Pools were indistinguishable as the visibility in the water column was minimal. Sediment in the channel was obscured by the cloudy water, but the gravel bars were observed to be extremely poorly sorted, consisting of all grain sizes from sand to large boulders (Photos 1 and 2, Appendix A).

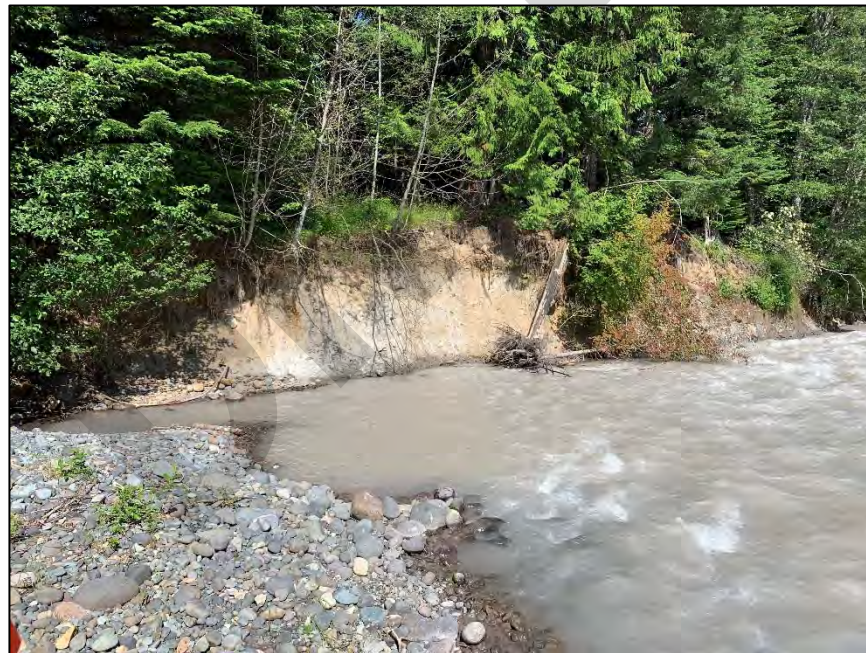
Photograph 2. Bar material and Osceola Mudflow along left bank near RM 50.4 and south end of Crystal River Ranch Community

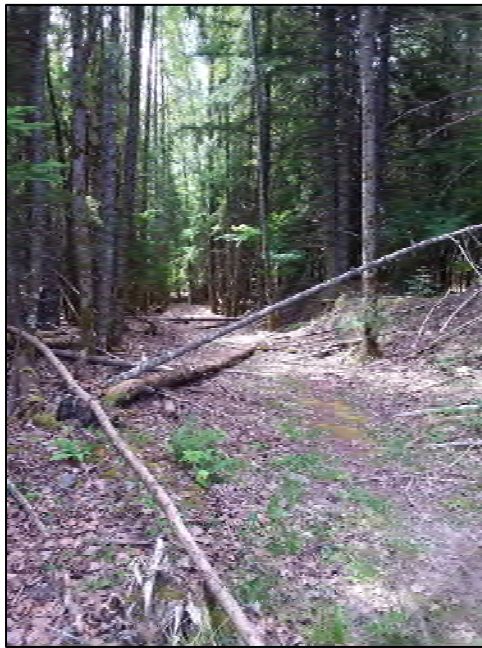
Photograph 3. One of numerous side channels within floodplain.

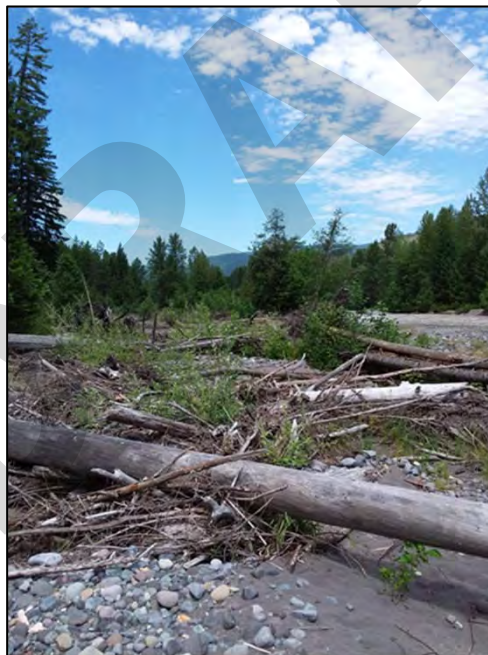
Photograph 4. Abundant large wood within Reach 5.

Abundant large wood was observed throughout Reaches 4 through 6 (Photo 4, Appendix A), and the top third of Reach 1; a moderate amount was observed in Reaches 2 and 3 and lower portion of Reach 1. A massive log jam was observed near the confluence with the Greenwater River.

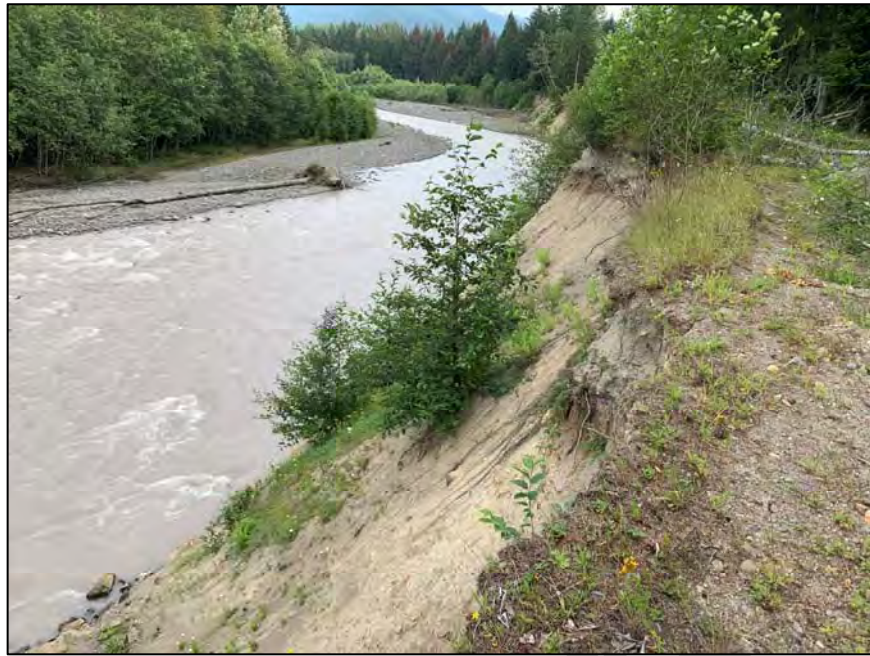
Photograph 5. Osceola Mudflow along left bank near RM 47, approximately 30 to 35 feet high.

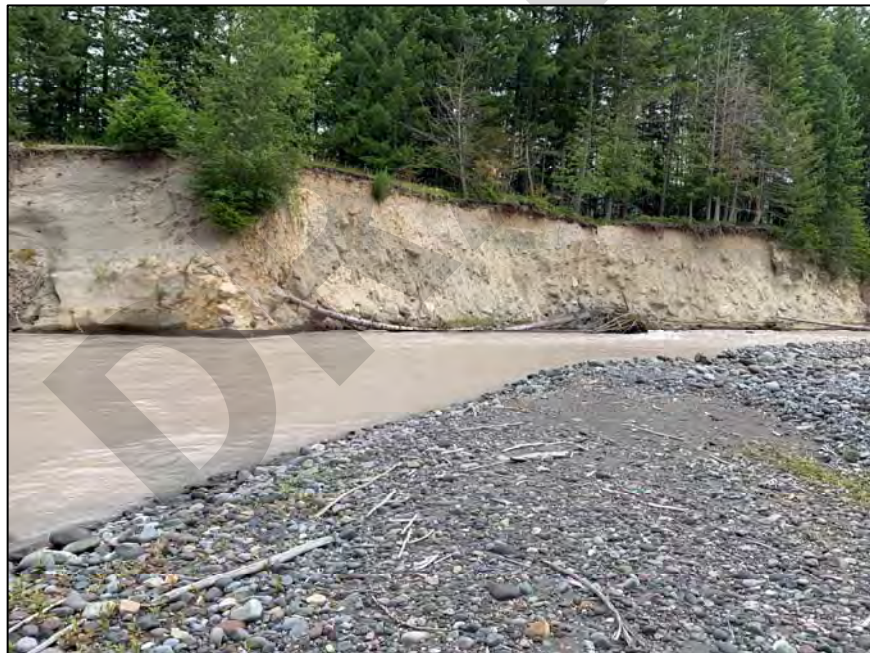
Photograph 6. High bank in Osceola Mudflow that is actively eroding.

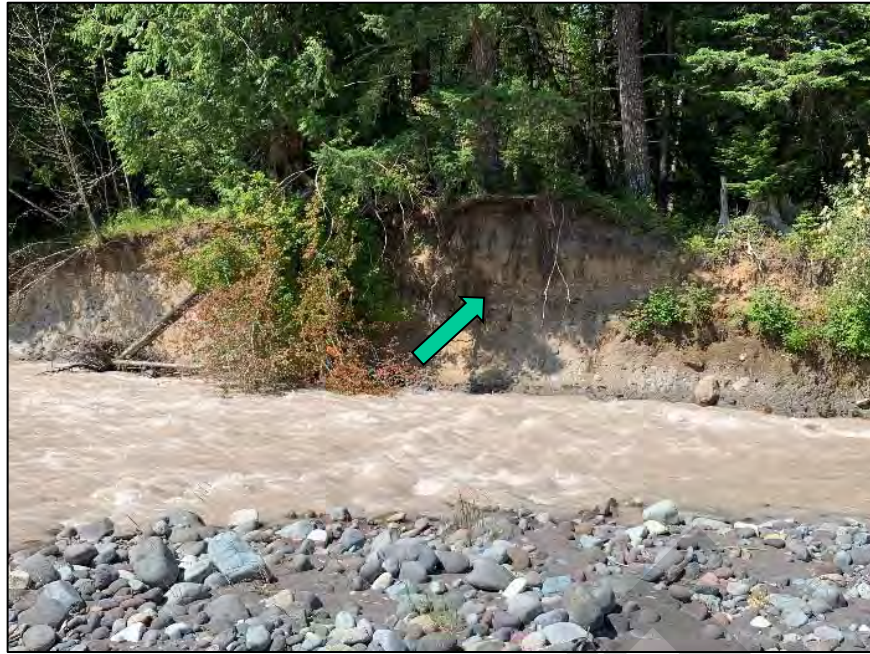
Photograph 7. Lower terrace of Osceola Mudflow at Crystal River Ranch. Osceola Mudflow at base of slope is overlain by approximately 4 to 6 feet of alluvial sediments with two different distinct layers; the lower is brown, the upper is gray.

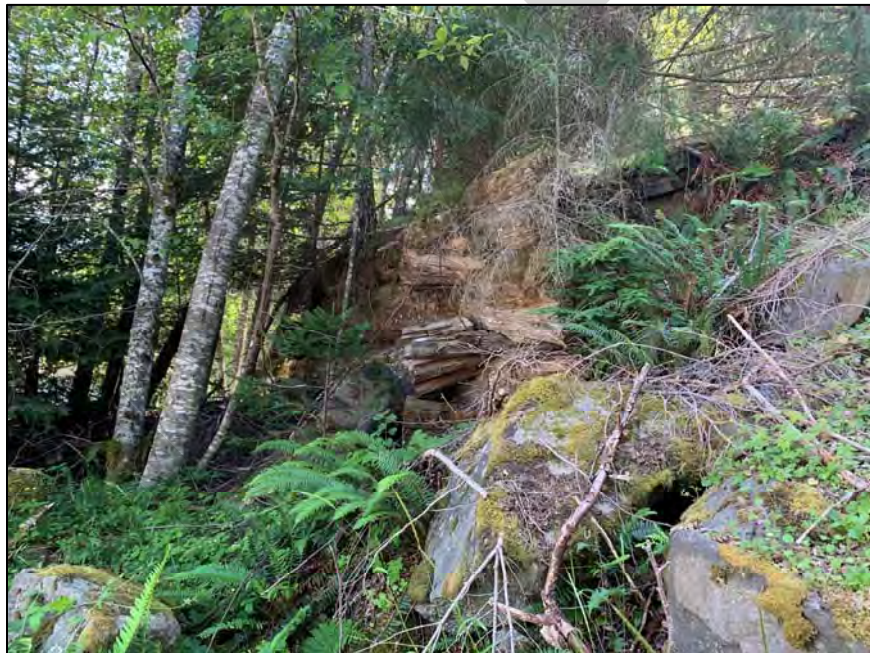
Photograph 10. Abutment to old bridge near RM 49.7 consists of massive riprap and wood.

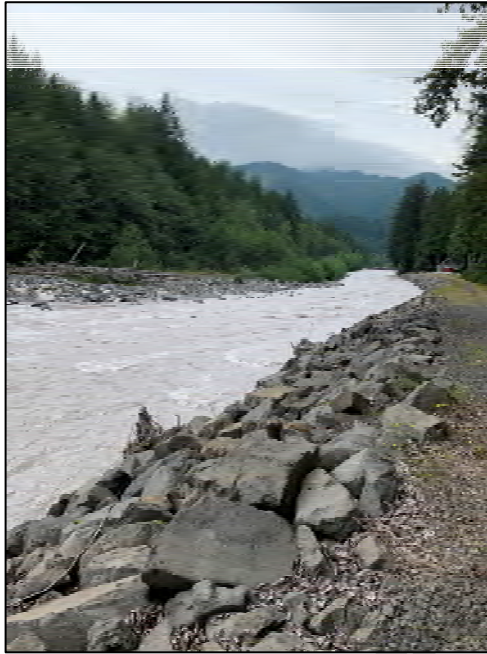
Photograph 11. Pierce County levee along right bank near RM 45.1.

- The levee at RM 45.5 is discontinuous and could be flanked; the area behind it is still connected to the river and, therefore, does not constitute a disconnected migration area.
- The levee at RM 46.5 is discontinuous and has no public commitment associated with it.
- The bridge at RM 47 is above the 100-year floodplain, but it is privately owned. Therefore, there is no public commitment for maintenance to keep it intact. Additionally, an avulsion hazard zone flanks the bridge to the east.

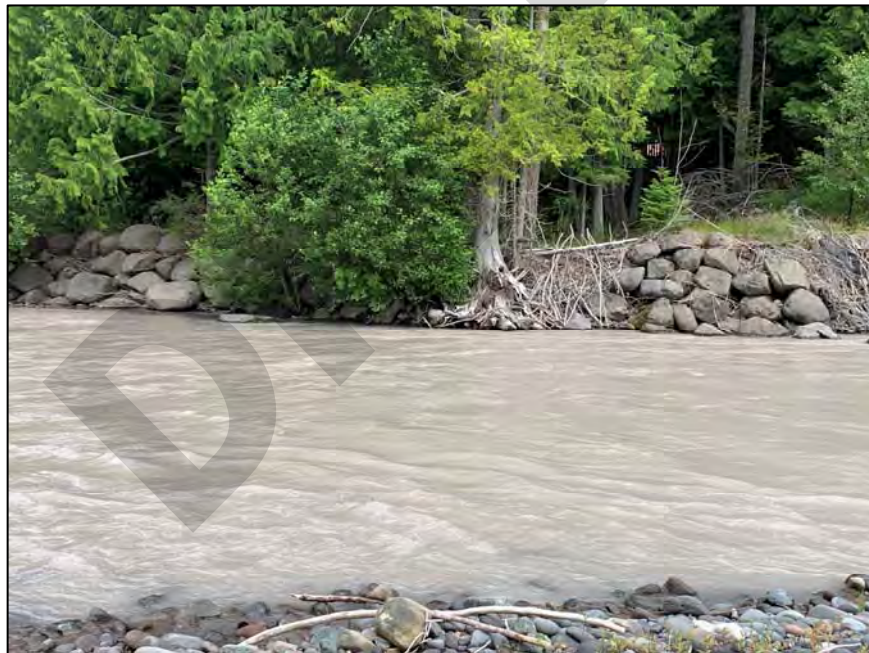
Photograph 12. Levee along right bank near RM 46.6.

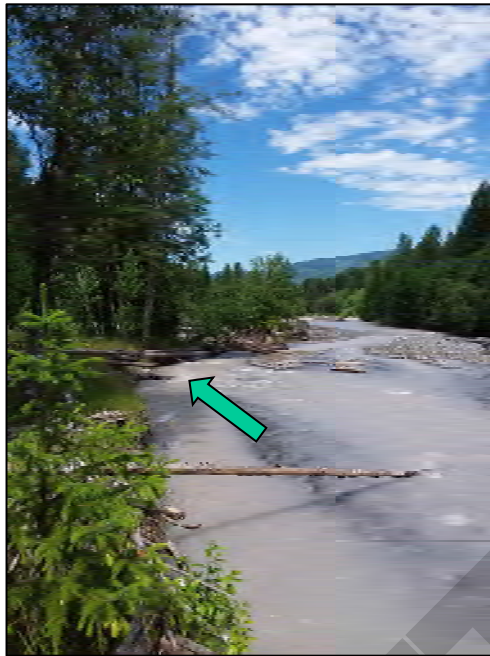
Photograph 13. Crystal River Ranch rock vane exposed.

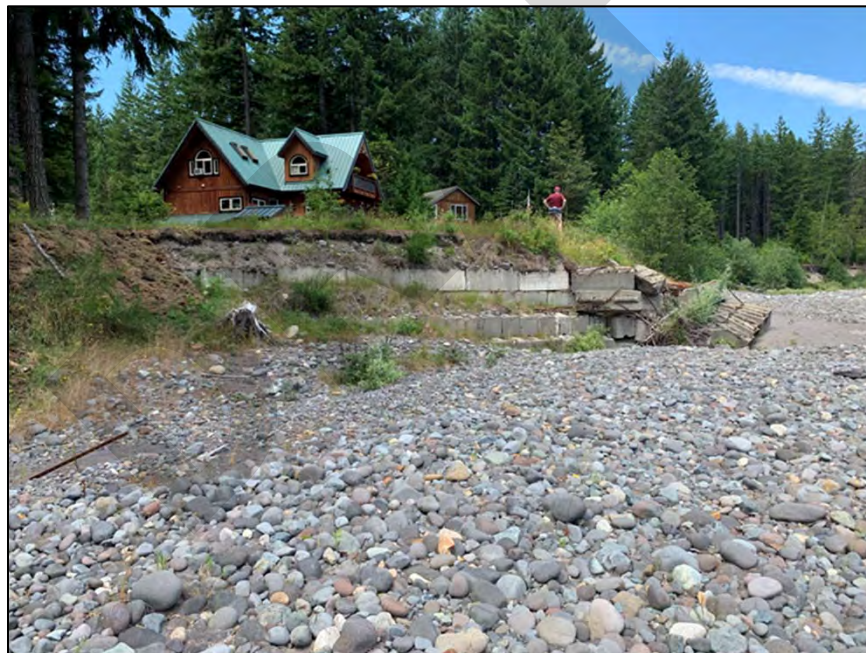
Photograph 14. Large ecology block revetment near RM 49.8.

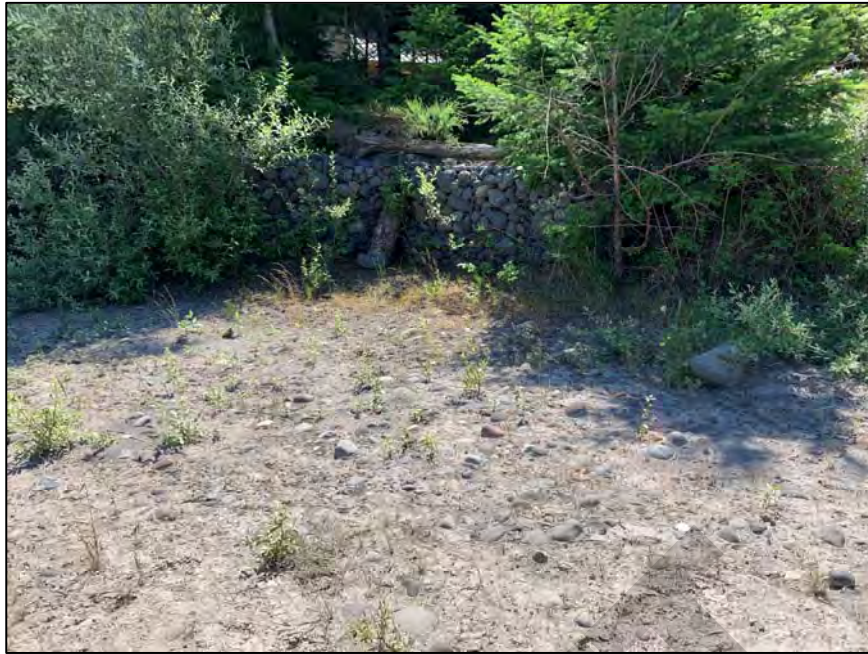
Photograph 15. Gabion basket revetment near RM 49.5.

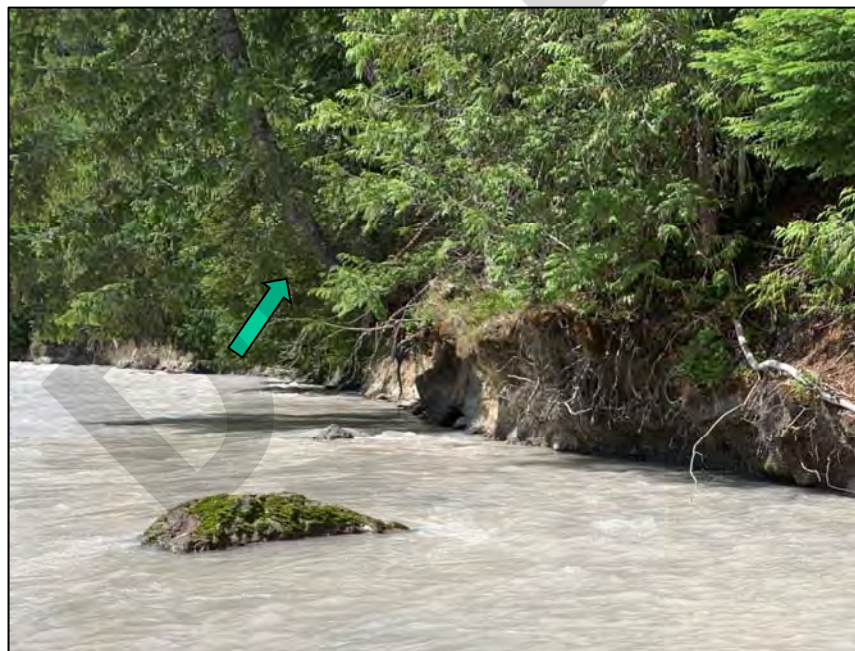
Photograph 16. Eroding Osceola Mudflow bank near Crystal River Ranch with pistol butt tree.

Pistol butt trees along left bank at Crystal River Ranch Community suggest that the slope has been relatively stable for some time (Photo 16, Appendix A). These field observations corroborate results from the desktop study, which found erosion took place between 1944 and 1962 along that bank but was arrested until recently. This provided time for the vegetation to grow on the bank. Fresh cut banks are evidence of recent erosion into the Osceola Mudflow along this bank.

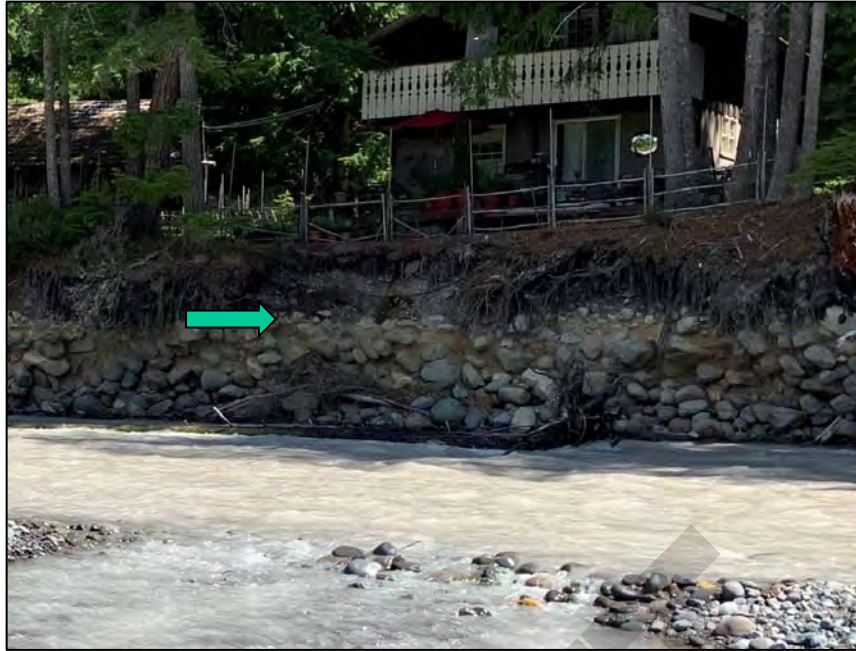
Photograph 17. Debris flow of unknown origin with alluvium and topsoil on top (arrow marks boundary).

An additional geologic unit was identified in the field along the right bank near RM 50. This unit consists of large, clast-supported, sub-angular to sub-rounded boulders, approximately 1 to 4 feet in diameter, and fewer cobbles within a matrix of sand and gravel (Photos 17 and 18, Appendix A). This unit is interpreted to be a separate debris flow or lahar of unknown origin. Zehfuss, et al. (2003) describe post Osceola lahars upstream of Enumclaw as being deposited in the debris flow phase and those found at river level as being “clast-supported, extremely poorly sorted, consisting of boulders (up to 2 meters [m] in diameter) and cobbles in a matrix of pebbles and sand.” Because of the size of the material in this unit, it is highly resistant to erosion.

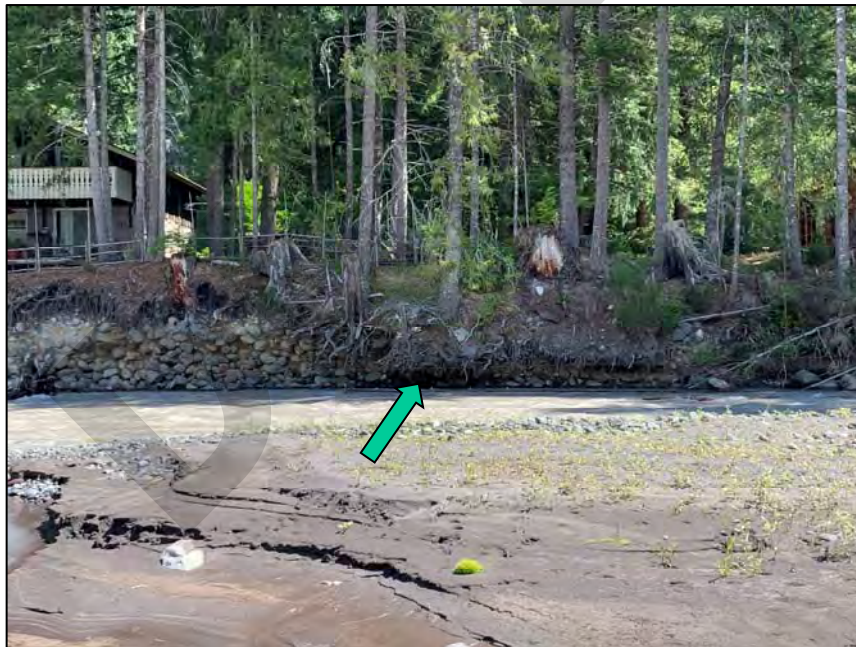
Photograph 18. Debris flow of unknown origin and significantly undercut bank. Tree growing atop of undercut with overhanging roots and other vegetation.
